Human Impact on the Headwater Environment In the Uporoto Highlands, Tanzania

*Cosmas H. Sokoni**

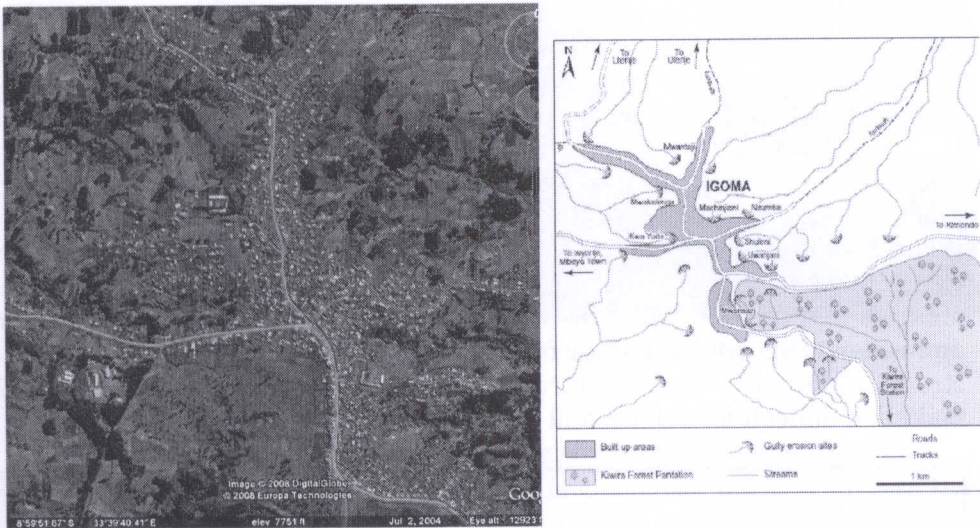
Figure 2: Aerial view of Igoma village and distribution of main gully sites

Figure 2 shows the structure, form and distribution of a greater part of Igoma village and the map shows the distribution of the main gully sites that surround and threaten destruction from all sides. Despite this danger no sustainable measures have been undertaken to check land degradation and gully extension. The sustainable management of the village's headwater areas calls for a better understanding of the human – environment interactions that have taken place in the village.

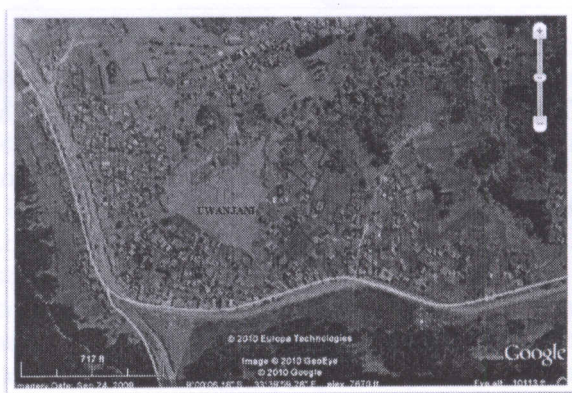
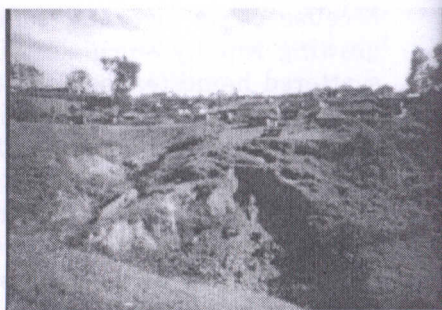
Figure 3: View of Uwanjani gully and built-up areas threatened by gully extension

Gully formation and its headward extension have impact on agricultural land and built-up area. Gully extension occurs through slumping of land at the gully head following heavy rainfall. Land suitable for agriculture and settlement is degraded in the process. Destruction of houses is reported at Kiwanjani area where landslides occurred on the sides of the gully several times (Fig. 3).

The stream gullies also are a threat to infrastructure. A gradual destruction of a bridge at Mwansazi eventually led to a diversion of the road that links Igoma with the Kiwira Forest Plantation station and serves as an outlet for sawn timber that reaches urban markets of Mbeya and Dar es Salaam (Fig. 4). Footpaths joining ridges are abandoned and farmers are forced to use longer routes to reach fields and neighbours. Gully erosion has gradually reduced the size of the football ground at Uwanjani (a 'natural stadium' as villagers could watch games from their homes) that has eventually been abandoned as it became too small and more risky to players (Fig. 3 above).

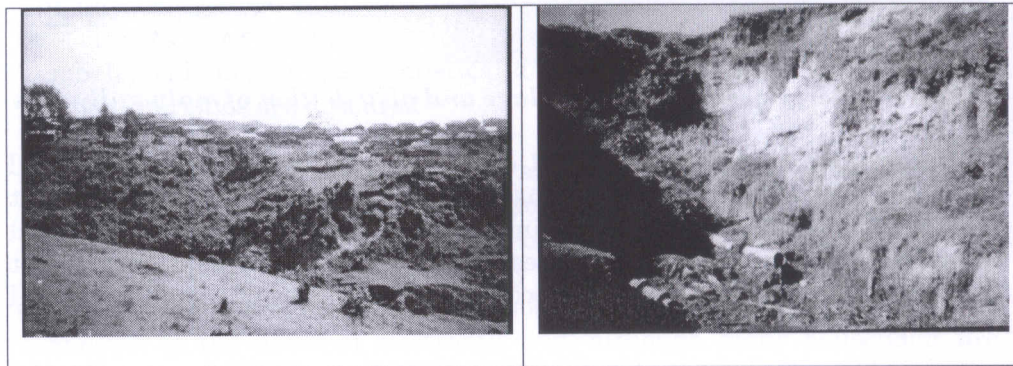
Plates 1 & 2: Gully extension into built up areas and structures for water collection

The distance from heads of gullies to built-up areas decreases though gradually, at Uwanjani, Kwa Yuda, Nzumba, Machinjioni and Mwantaji sites (Plate 1). At Uwanjani, the gully is only 60 meters from the local government

office building. Although the village has piped water supply since 1999, some villagers still rely on gullies for water because piped water supply is erratic and water tapes are located far from the homesteads. Slumping of gully head structure destructs the structures constructed for drawing water (Plate 2) making it difficult for women and children to fetch water.
